**Flood Control Project Maintenance  
Levee Inspections**  
**LMA District Cover Sheet**  
**Spring 2008 Levee Inspection Results**

**Reclamation District No. 0017**

**Levee Inspection Report By Mile - Spring 2008**

Waterway							Bank	Unit Miles	Inspection Date	Inspector	
Unit No. 01 French Camp Slough							Left	1.80	03/10/2008	Richard Willoughby	
LMR Line	Levee Mile		Category	Item	* Location	** Rating	Action/Comment	GPS Latitude/Longitude		Photo	Issue
	Start	End						Start	End		
1	0.00	0.02	Earthen Levee	Encroachments	WS	PO	Fences	37.911203 ° -121.291093 °	37.911385 ° -121.291307 °	Y	4
2	0.00	0.12	Earthen Levee	Trim / Thin Trees	WS	M	Trim trees to at least five feet above ground level.	37.909207 ° -121.290972 °	37.912553 ° -121.292552 °		3
3	0.00	1.81	Earthen Levee	Vegetation	WS	M	Control annual grass and weeds on the levee slopes and easements.	37.909208 ° -121.290967 °	37.915937 ° -121.320838 °		1
4	0.00	1.81	Earthen Levee	Vegetation	LS	M	Control annual grass and weeds on the levee slopes and easements.	37.909207 ° -121.290970 °	37.915938 ° -121.320838 °		2
5	0.17	1.80	Earthen Levee	Animal Control	WS	M	Exterminate rodents and backfill and compact or grout burrows.	37.912990

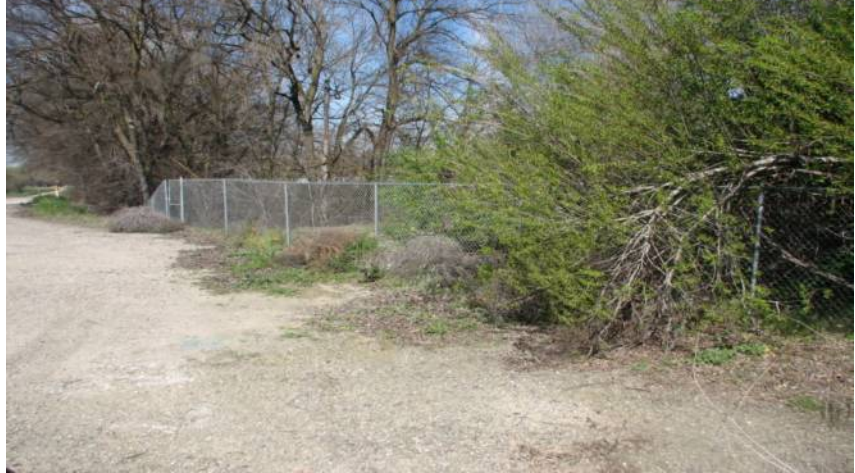
Levee Mile Report Line	1
Start Levee Mile	0.00
End Levee Mile	0.02
Location	
Category	Earthen Levee
Item	Encroachments
Fence on landside shoulder from LM 0.00 to 0.02

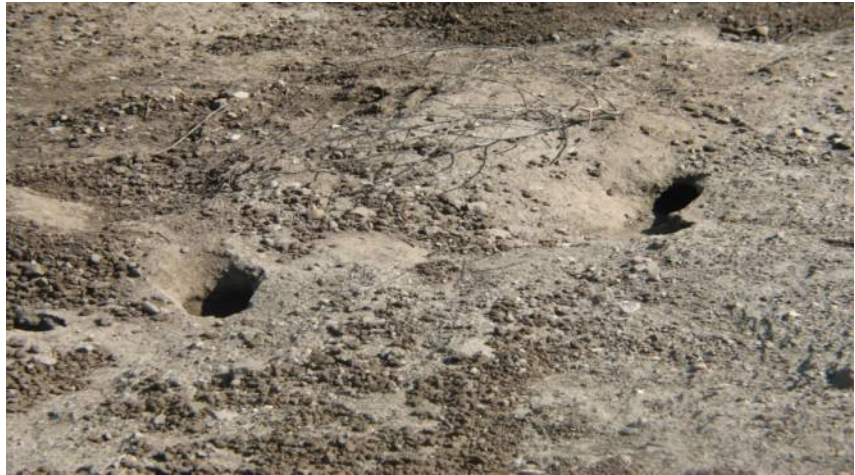
Levee Mile Report Line	6
Start Levee Mile	2.19
End Levee Mile	2.60
Location	
Category	Earthen Levee
Item	Animal Control
Squirrel borrows on landside slope heavy infestation from LM 2.19 to 2.60

6	2.19	2.60	Earthen Levee	Animal Control	LS	M	Exterminate rodents and backfill and compact or grout burrows. Inspector Comments: Heavy infestation of squirrels in this section	37.887702 ° -121.329528 °	37.882290 ° -121.331538 °	Y	6
7	2.27	2.29	Earthen Levee	Trim / Thin Trees	WS	M	Trim trees to at least five feet above ground level.	37.886903 ° -121.330670 °	37.886707 ° -121.330793 °		7
8	2.75	2.75	Earthen Levee	Encroachments	WS	M	Garbage	37.880228 ° -121.331947 °	37.880228 ° -121.331947 °		8
9	3.03	3.08	Earthen Levee	Vegetation	WS	M	Remove the wild growth other than native grasses from the levee slopes.	37.876360 ° -121.331437 °	37.875573 ° -121.331837 °		9
10	4.10	4.10	Earthen Levee	Trim / Thin Trees	LS	M	Trim trees to at least five feet above ground level.	37.864882 ° -121.323068 °	37.864882 ° -121.323068 °		10
11	4.28	4.32	Earthen Levee	Encroachments	LS	M	Crops	37.863582 ° -121.320230 °	37.862947 ° -121.319812 °	Y	11

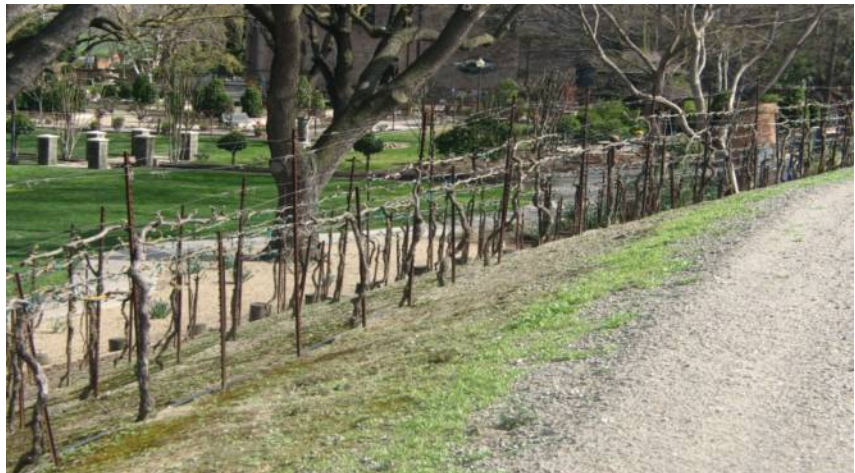
Levee Mile Report Line	11
Start Levee Mile	4.28
End Levee Mile	4.32
Location	
Category	Earthen Levee
Item	Encroachments
Grape vines on landside slope from LM 4.28 to 4.32

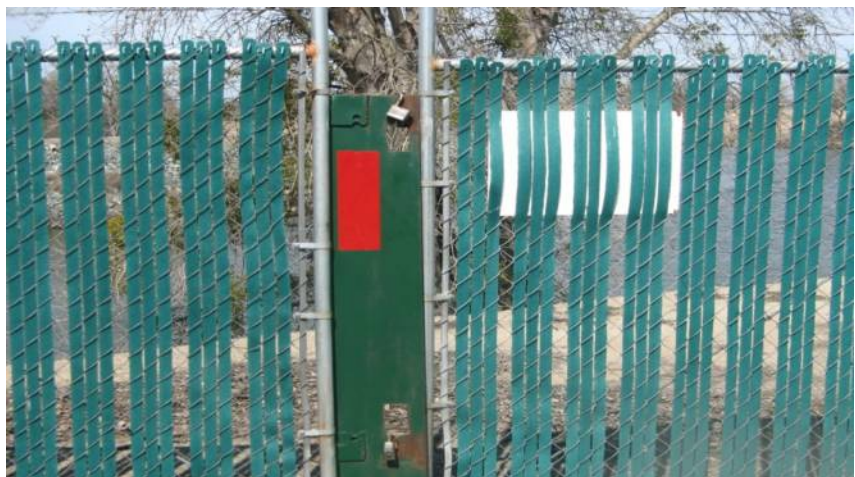
Levee Mile Report Line	12
Start Levee Mile	4.40
End Levee Mile	4.40
Location	
Category	Earthen Levee
Item	Repair Gates
Gate at LM 4.40 hard to lock gate due to alignment of gate.

12	4.40	4.40	Earthen Levee	Repair Gates	CR	A	Inspector Comments: Hard to lock gate, need new locking system	37.861703 ° -121.320148 °	37.861703 ° -121.320148 °	Y	12
13	4.54	4.54	Earthen Levee	Encroachments	LS	A	Tree or limb Inspector Comments: Need to trim oleander back off gate hard to access lock.	37.860693 ° -121.318513 °	37.860693 ° -121.318513 °	Y	13
14	4.55	4.69	Earthen Levee	Trim / Thin Trees	LS	M	Trim trees to at least five feet above ground level.	37.860607 ° -121.318442 °	37.858868 ° -121.317368 °		14
15	4.58	4.60	Earthen Levee	Vegetation	WS	U	Remove the wild growth other than native grasses from the levee slopes. Inspector Comments: Remove dead bamboo.	37.860395 ° -121.317962 °	37.860170 ° -121.317622 °	Y	15
16	5.01	5.01	Earthen Levee	Trim / Thin Trees	LS	M	Trim trees to at least five feet above ground level.	37.855163 ° -121.319817 °	37.855163 ° -121.319817 °		16
17	5.55	5.55	Earthen Levee	Encroachments	WS	M	Tree or limb Inspector Comments: cut and remve broken tree limb from levee slope.	37.850507 ° -121.320432 °	37.850507 ° -121.320432 °	Y	17

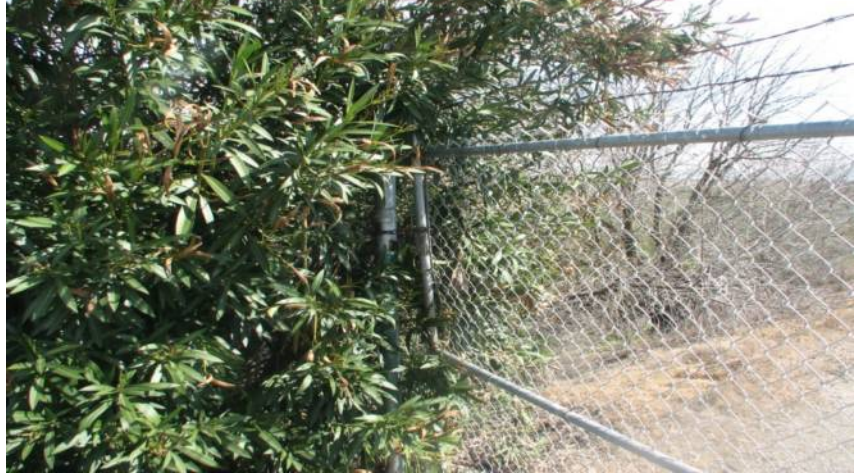
Levee Mile Report Line	13
Start Levee Mile	4.54
End Levee Mile	4.54
Location	
Category	Earthen Levee
Item	Encroachments

Gate at LM 4.54 (Trim back Oleander)

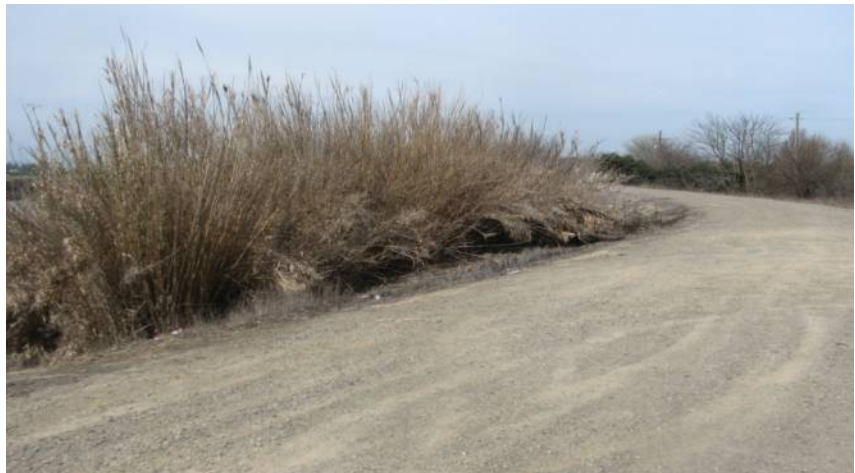
Levee Mile Report Line	15
Start Levee Mile	4.58
End Levee Mile	4.60
Location	
Category	Earthen Levee
Item	Vegetation

Dead bamboo on waterside slope at LM 4.58  
(Remove dead bambo)

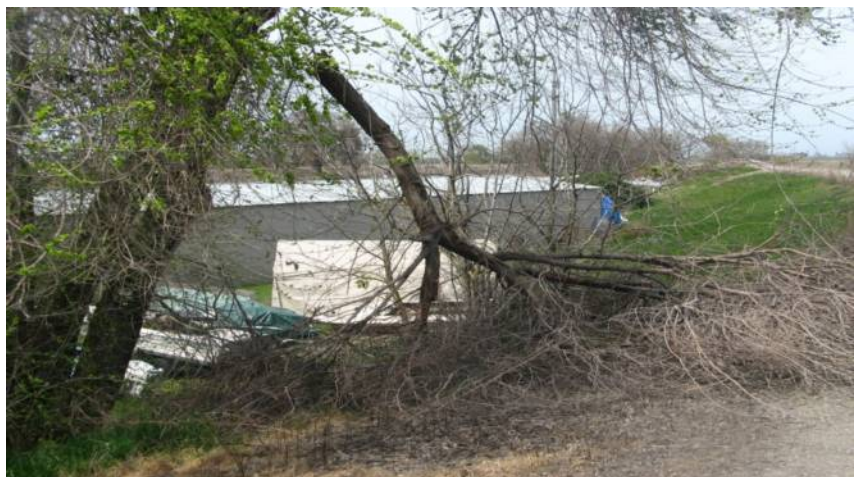
Levee Mile Report Line	17
Start Levee Mile	5.55
End Levee Mile	5.55
Location	
Category	Earthen Levee
Item	Encroachments

Broken tree limb at LM 5.55

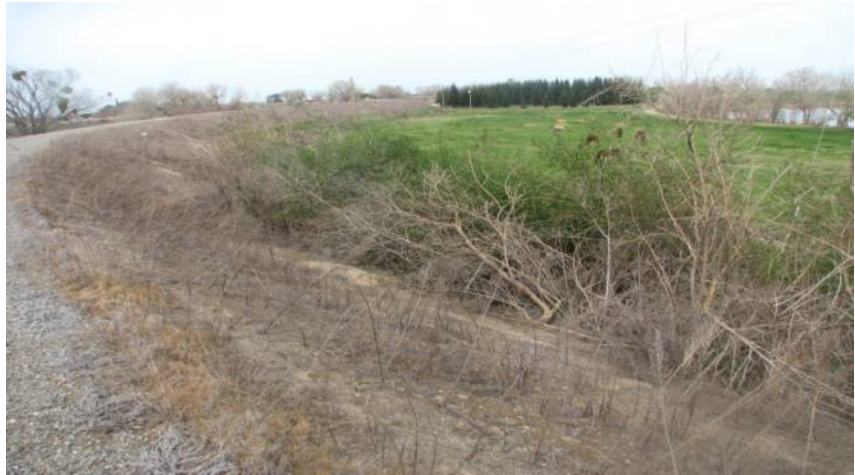
Levee Mile Report Line	22
Start Levee Mile	6.35
End Levee Mile	6.36
Location	
Category	Earthen Levee
Item	Vegetation
Elderberry blocking view of waterside toe from LM 6.35 to 6.36

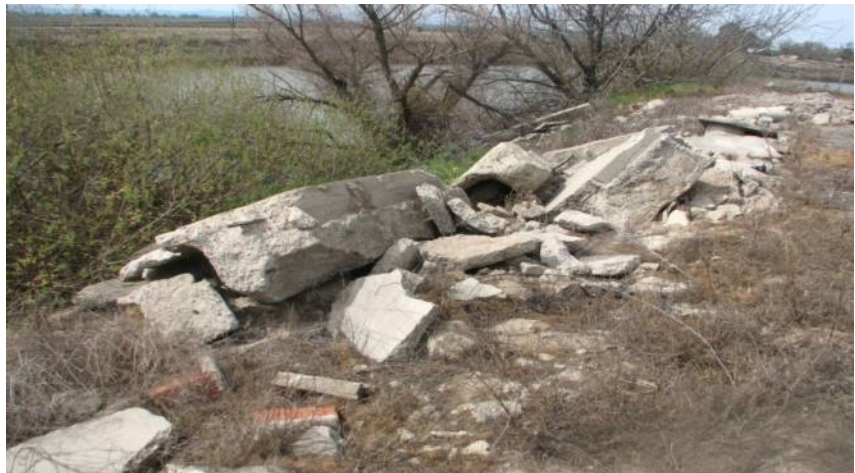
Levee Mile Report Line	24
Start Levee Mile	7.11
End Levee Mile	7.11
Location	
Category	Earthen Levee
Item	Encroachments
Concrete rubble with rebar at LM 7.11 on waterward slope.

23	6.63	6.63	Earthen Levee	Trim / Thin Trees	WS	M	Trim trees to at least five feet above ground level.	37.841095 ° -121.315725 °	37.841095 ° -121.315725 °		23
24	7.11	7.11	Earthen Levee	Encroachments	WS	M	Material Inspector Comments: Concrete rubble should be removed or broken up and remove rebar and spread out evenly on waterward slope	37.834948 ° -121.314842 °	37.834948 ° -121.314842 °	Y	24
25	7.67	7.69	Earthen Levee	Vegetation	LS	M	Remove the wild growth other than native grasses from the levee slopes.	37.828095 ° -121.309945 °	37.827920 ° -121.309847 °	Y	25
26	8.02	8.02	Earthen Levee	Trim / Thin Trees	WS	M	Trim trees to at least five feet above ground level.	37.823928 ° -121.310788 °	37.823928 ° -121.310788 °		26
27	9.02	9.02	Earthen Levee	Trim / Thin Trees	LS	M	Trim trees to at least five feet above ground level.	37.818997 ° -121.315258 °	37.818997 ° -121.315258 °		27
28	10.27	10.34	Earthen Levee	Encroachments	WS	M	Material Inspector Comments: Concrete rubble should be removed or broken up and spread out along slope.	37.809935 ° -121.324115 °	37.809418 ° -121.325215 °	Y	28

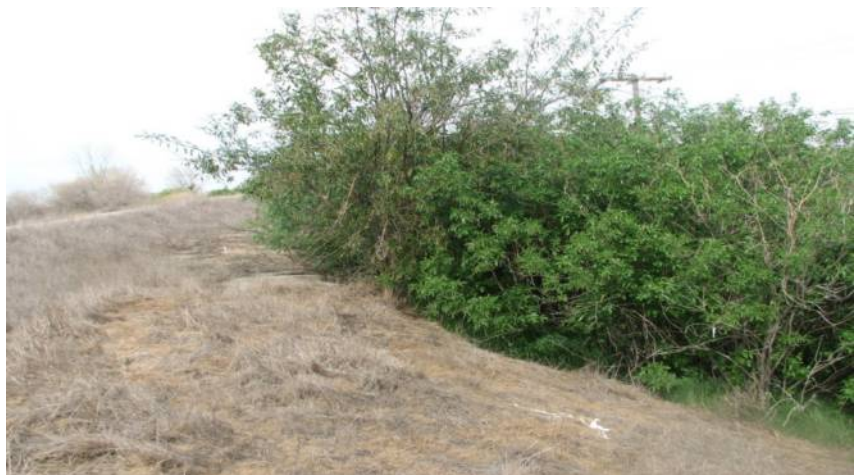
Levee Mile Report Line	25
Start Levee Mile	7.67
End Levee Mile	7.69
Location	
Category	Earthen Levee
Item	Vegetation
Elderberry blocking view of landside slope and toe from LM 7.67 to 7.69

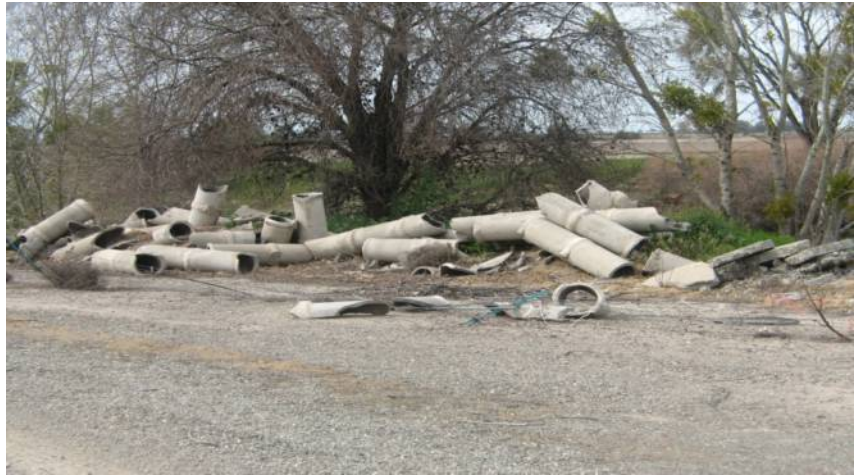
Levee Mile Report Line	28
Start Levee Mile	10.27
End Levee Mile	10.34
Location	
Category	Earthen Levee
Item	Encroachments
Concrete rubble on waterward shoulder from LM 10.27 to 10.34

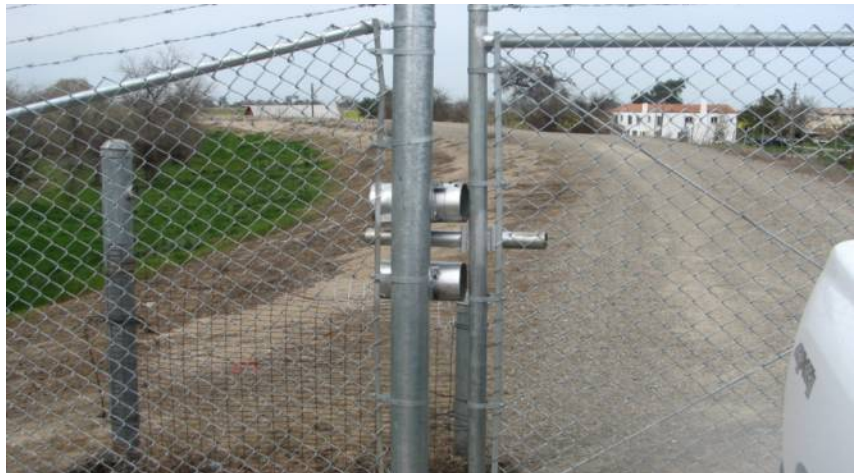
Levee Mile Report Line	30
Start Levee Mile	11.42
End Levee Mile	11.42
Location	
Category	Earthen Levee
Item	Repair Gates
Gate with a faulty locking system at LM 11.42

29	11.10	11.24	Earthen Levee	Trim / Thin Trees	LS	M	Trim trees to at least five feet above ground level.	37.806697 ° -121.316430 °	37.805820 ° -121.314088 °		29
30	11.42	11.42	Earthen Levee	Repair Gates	CR	A	Inspector Comments: Need to change locking system. To difficulty to lock and unlock gate.	37.803762 ° -121.312027 °	37.803762 ° -121.312027 °	Y	30
31	11.90	11.90	Earthen Levee	Encroachments	WS	M	Tree or limb	37.797467 ° -121.311045 °	37.797467 ° -121.311045 °	Y	31
32	12.72	12.72	Earthen Levee	Trim / Thin Trees	LS	M	Trim trees to at least five feet above ground level.	37.787730 ° -121.307095 °	37.787730 ° -121.307095 °		32
33	13.45	13.45	Earthen Levee	Trim / Thin Trees	WS	M	Trim trees to at least five feet above ground level.	37.779355 ° -121.299948 °	37.779355 ° -121.299948 °		33
34	13.62	13.62	Earthen Levee	Trim / Thin Trees	LS	M	Trim trees to at least five feet above ground level.	37.777212 ° -121.298555 °	37.777212 ° -121.298555 °		34

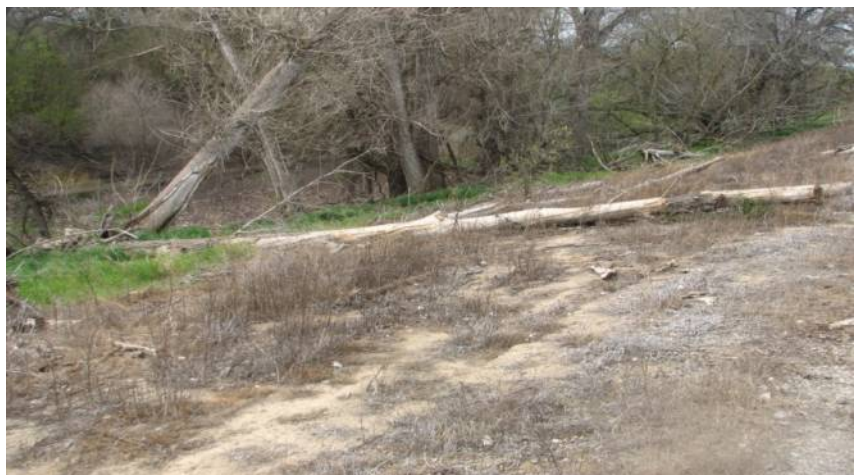
Levee Mile Report Line	31
Start Levee Mile	11.90
End Levee Mile	11.90
Location	
Category	Earthen Levee
Item	Encroachments
Tree limbs on waterward slope at LM 11.90

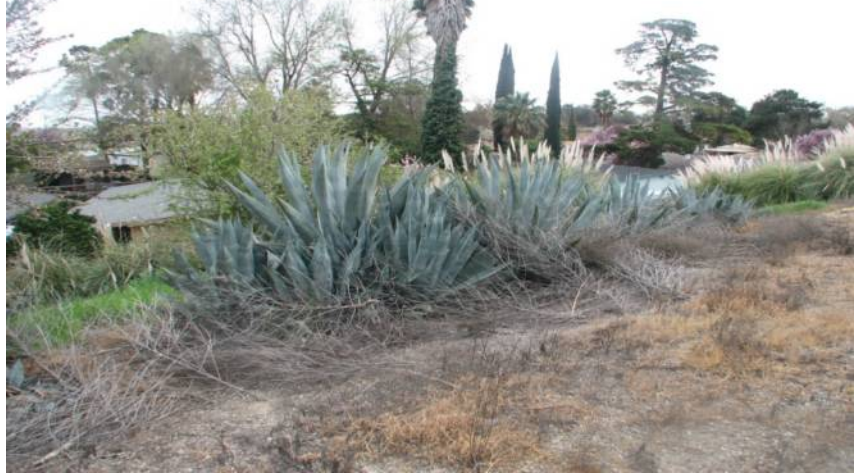
Levee Mile Report Line	35
Start Levee Mile	13.66
End Levee Mile	13.66
Location	
Category	Earthen Levee
Item	Encroachments
Catus (Landscaping) on landside slope blocking view at LM 13.66

35	13.66	13.66	Earthen Levee	Encroachments	LS	PO	Landscaping	37.776618 ° -121.298610 °	37.776618 ° -121.298610 °	Y	35
